Philips 22PFL3504D Power Transformer Replacement

This set was given to me due to excessive humming noises, frequent shut-off, as well as difficulty to turn it on. The most common issue for that is a failing transformer.

Written By: oldturkey03

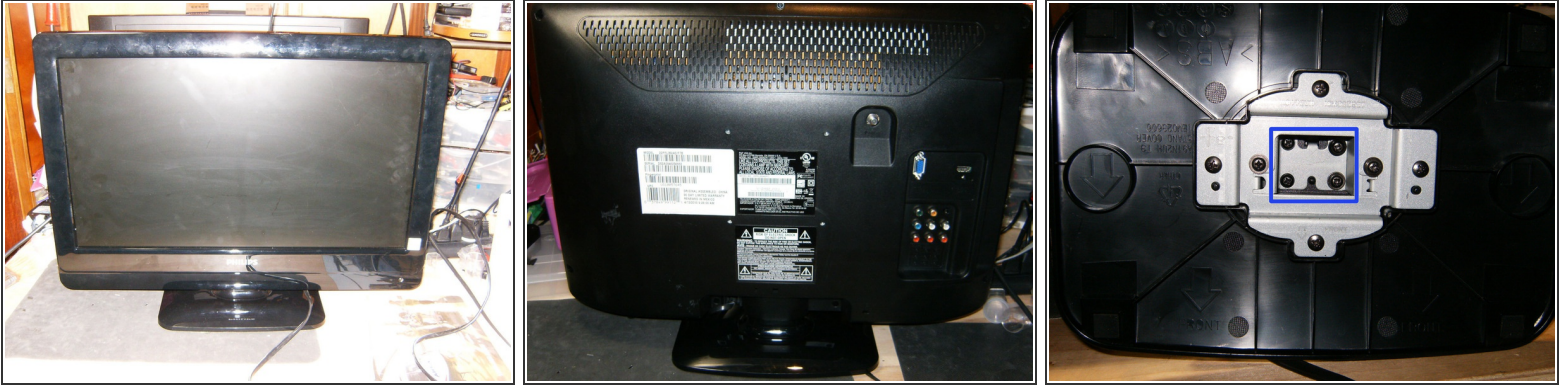
Step 1 — Power Transformer

- Here is the Philips 22PFL3504D. Fingerprints are definitely visible on the glossy front bezel and the LCD. those are really just smudges.
- Turn the TV over and lay it down,
- this will show the four Philips head screws that hold the base on to the TV

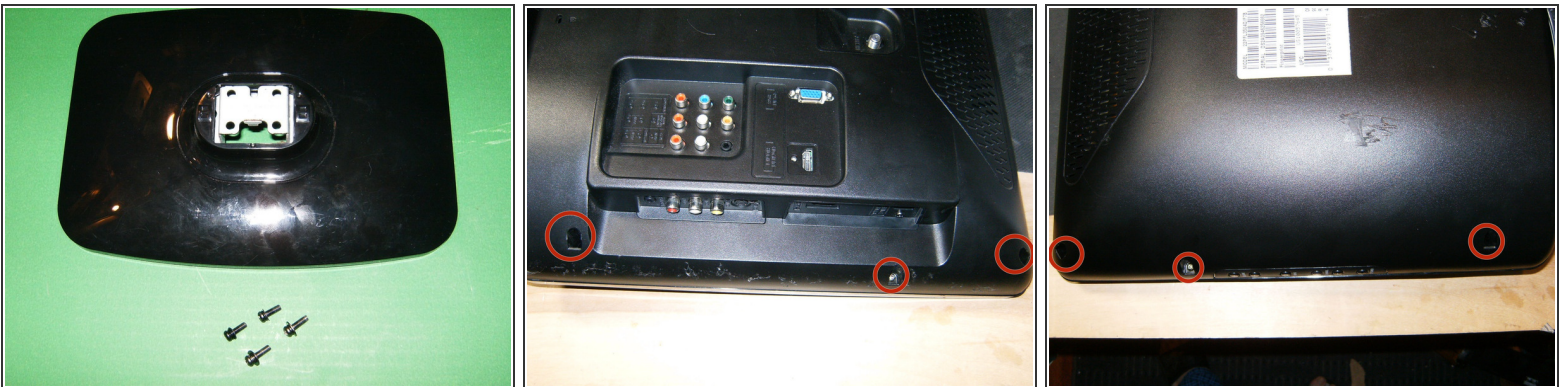
Step 2

- With the four M3X15 mm screws removed, the base can be taken off.
- Remove the three Philips head screws on the right side
- Remove the three Philips head screws on the left side.

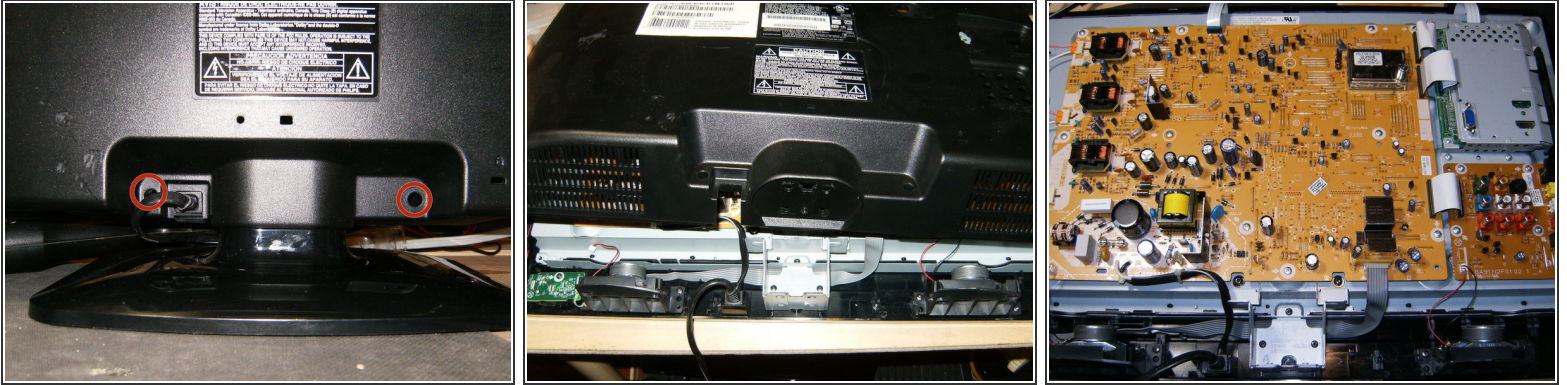
Step 3

- Remove the two Philips head screws on the bottom
- The back cover can now be removed by simply lifting it up.
- Here is a view of the layout of this TV. Clean and tidy with only a few ribbon cables.

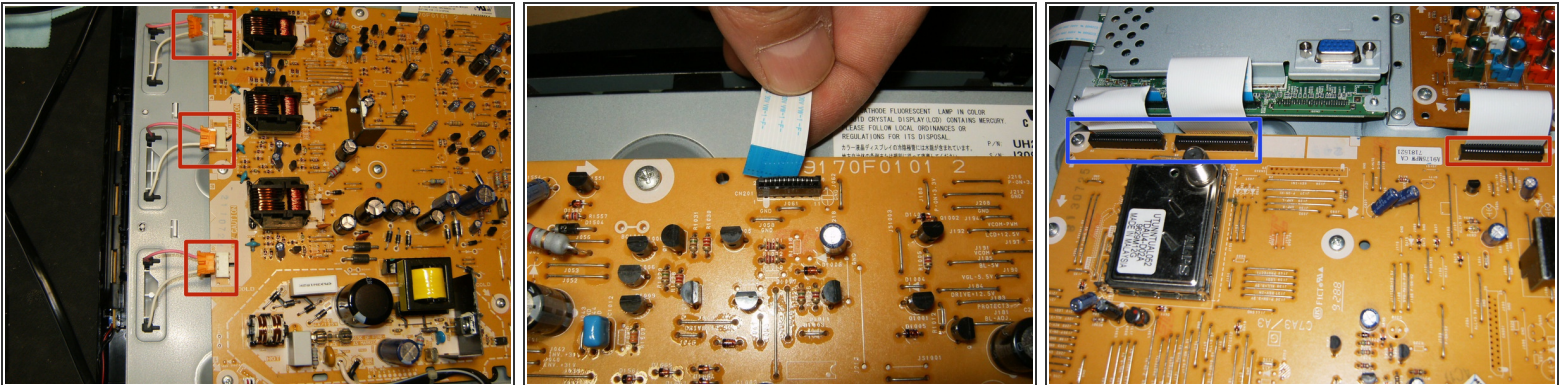
Step 4

- Remove the three CCFL connectors
- Remove the top flat ribbon cable. it is a simple press fit and just needs to be pulled out.
- remove the two and flat ribbon cables from the video board,
 - as well as the ribbon cable from the interface board.

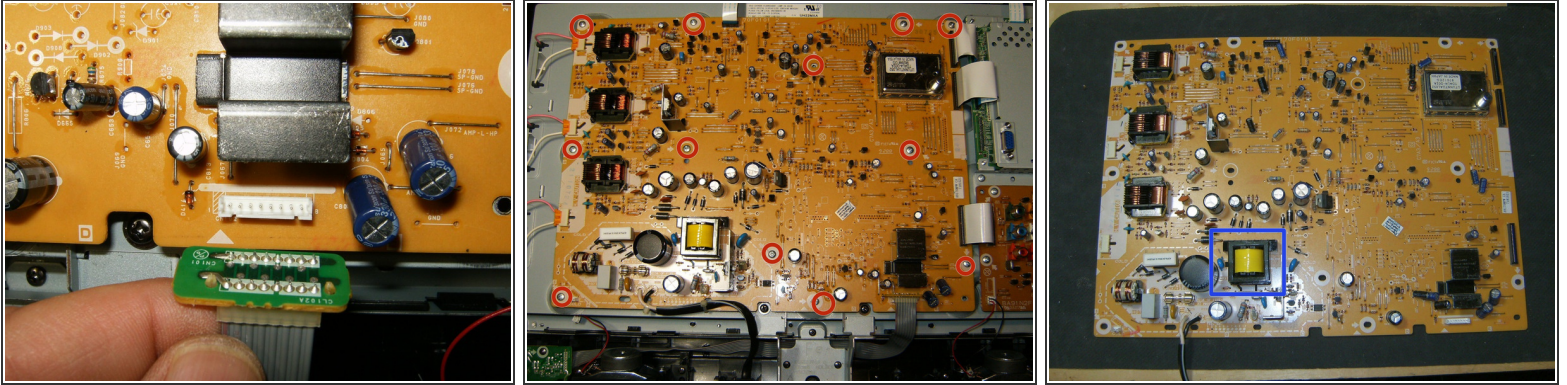
Step 5

- Remove the power button cable. It is a eight pin connetor and needs to be pulled up
- Remove the twelve M3x6mm Philips head screws
- Remove the board from the TV
 - this is the transformer that needs to be replaced.

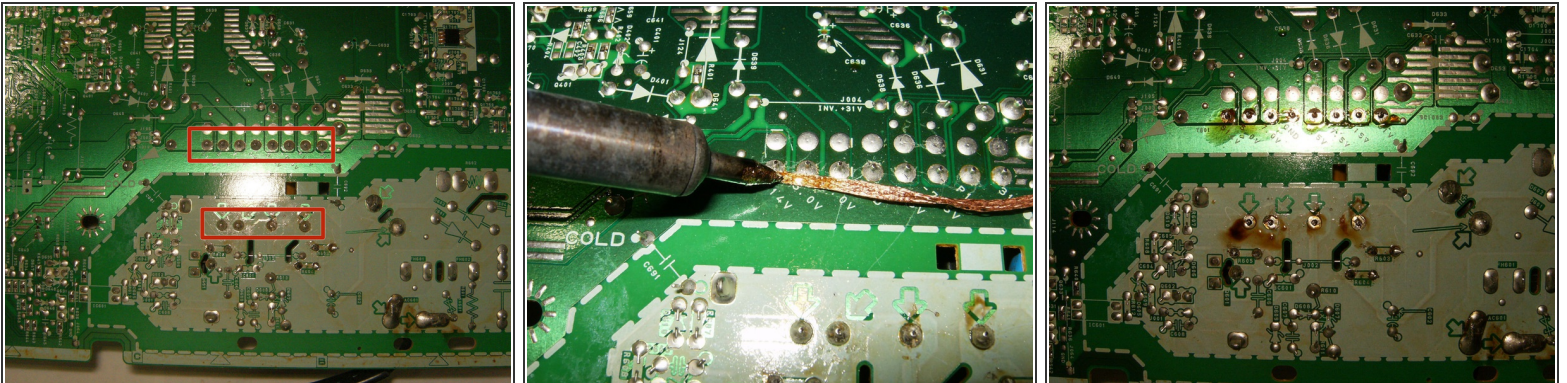
Step 6

- Turn the board over so that the solder points are up. Identify the connections for the transformer
- Use some flux on the desolder wick and desolder the contacts.
- The wick leaves the contacts without any solder, which will help to easily remove the transformer.

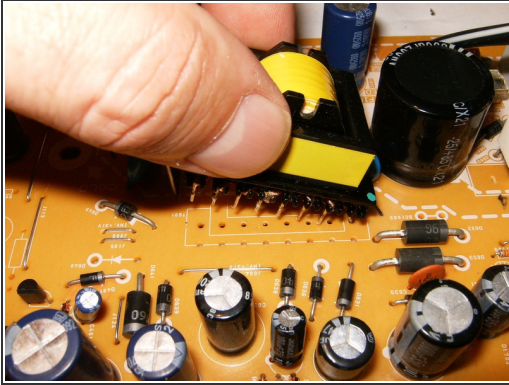
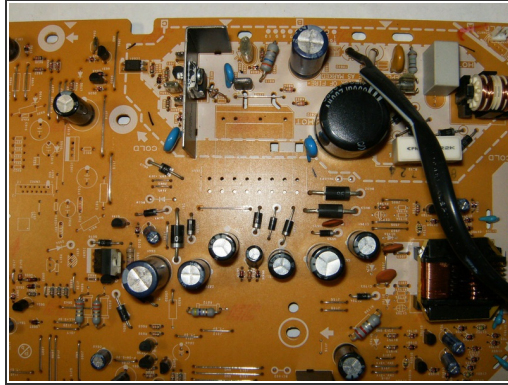
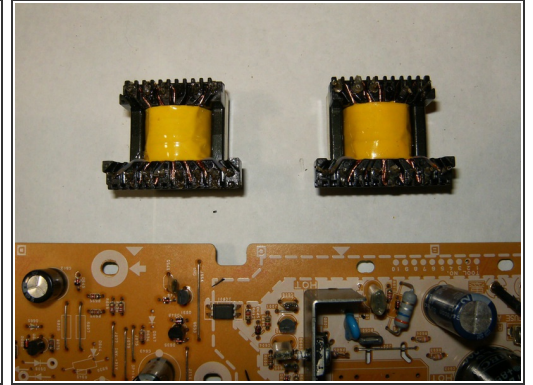
Step 7

- Turn the board component side up and remove the transformer
- Here is the board with the transformer removed.
- Always make sure the the replacement parts are identical in size and contacts. I like to compare the old (right) to the new (left)

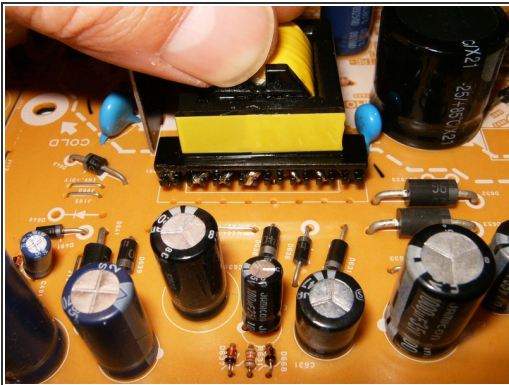
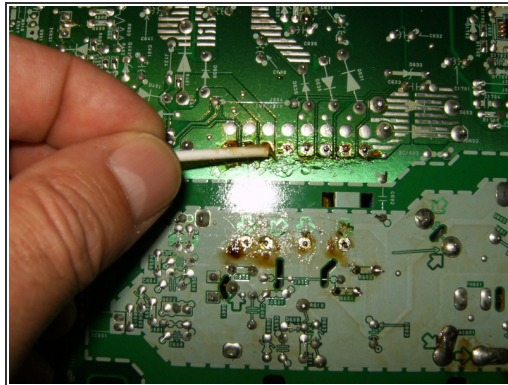
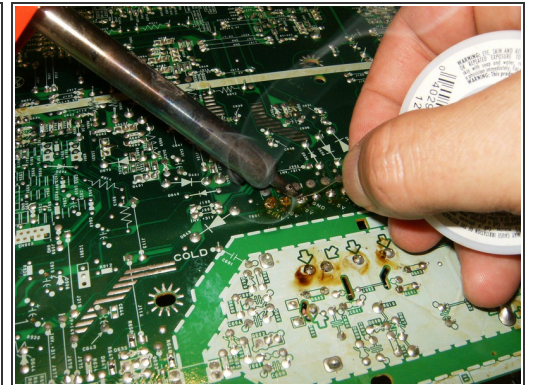
Step 8

- Insert the new transformer gently through the holes on the board.
- Turn the logic board component side down, identify the transformer contacts. Apply some flux to the contacts.
- Solder the new transformer in place. The brownish residue is from the flux. The board can be cleaned with isopropyl alcohol after the solder repair.

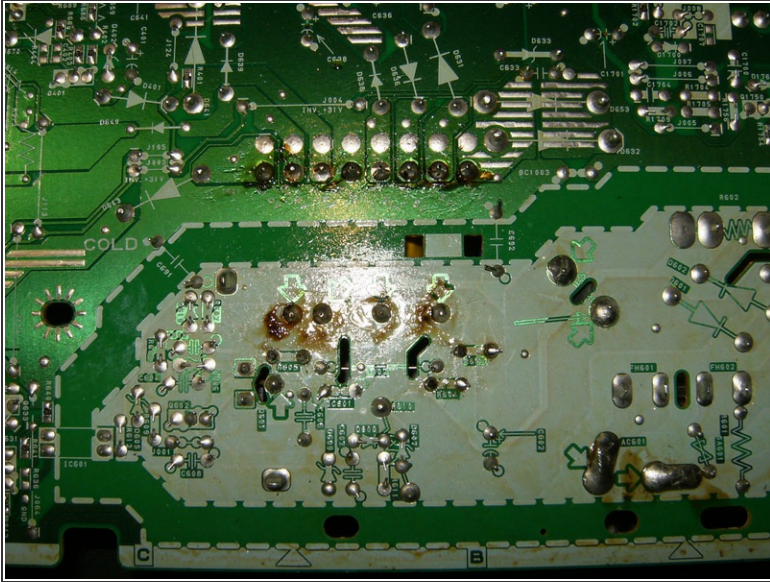
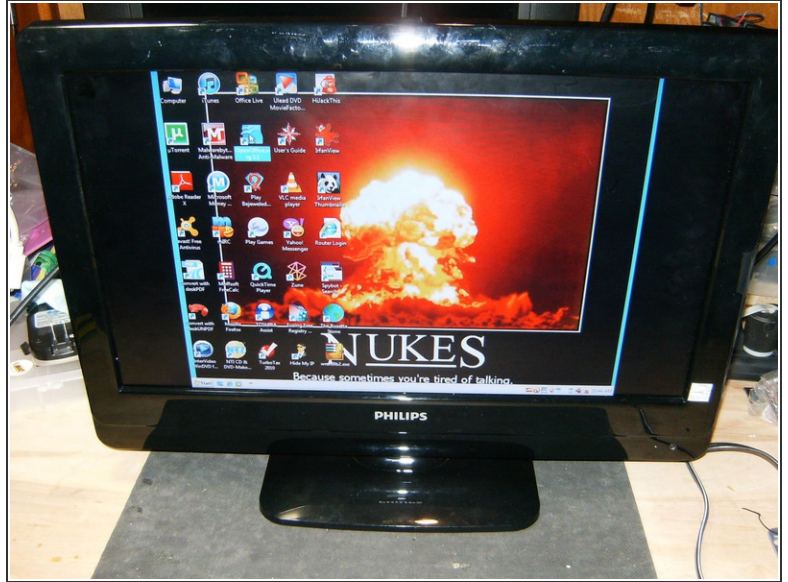
Step 9

- Ensure the all connections have been soldered and no accidental solder bridge was created. If it all looks satisfactory, reassemble the TV
- After the repair and reassembly. hopefully this is what you will see. A perfect picture and no disturbing humming
